Intake air manifold leaking

E31, E38, E39 with M62

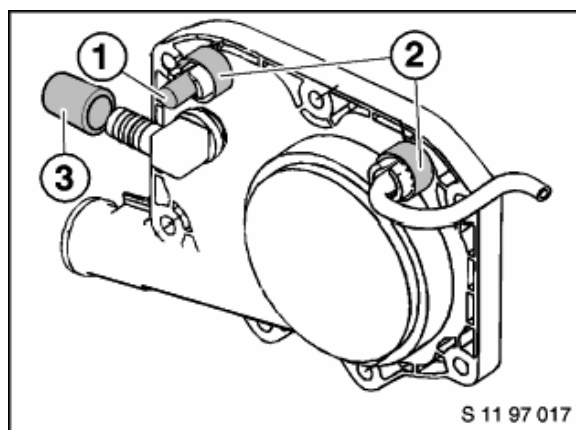
Fig. 1: Sealing cover on manifold, rear

Situation: Leaks in the intake air manifold can adversely affect the idling characteristics of the M62 engine. The fault entry 27 and/or 35 with the fault type "Mixture at the Lambda oxygen sensor too lean" is stored in the DME fault memory. In such cases, the "Check engine" lamp will light up on US vehicles.
Leaks can occur

- at the gaskets between the manifold and the cylinder heads due to the different thermal expansion characteristics of the different components
- at the vacuum connections on the rear end cover of the manifold due to porous sealing caps or connections

- Procedure:**
1. Remove the intake air manifold
Please refer to repair instructions 11 61 050
 2. Replace the sealing cap (1) on the vacuum connection and secure it with a retainer ring (2) (please refer to Fig. 1)
 3. Secure the fuel pressure regulating valve vacuum hose with a retainer ring (2) (please refer to Fig. 1)

Note: The retainer rings (2) should be fitted so that the lugs on the retainer rings point downwards and sit against the sealing cover

4. Renew the sealing cap (3) on the vacuum connection (E31 only) (please refer to Fig. 1)
5. Install the intake air manifold using new gaskets
