Intake air manifold leaking

E31, E38, E39 with M62

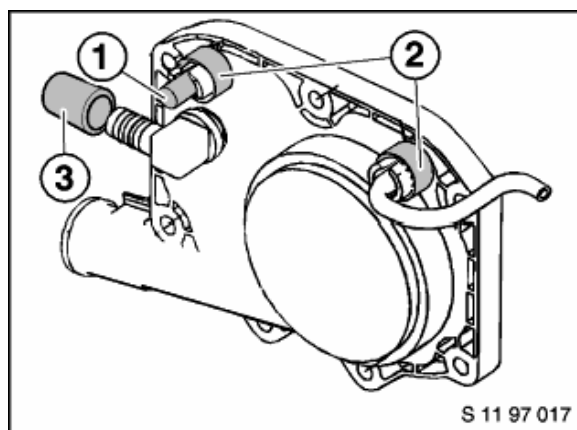
- at the gaskets between the manifold and the cylinder heads due to the different thermal expansion characteristics of the different components
- at the vacuum connections on the rear end cover of the manifold due to porous sealing caps or connections

Fig. 1: Sealing cover on manifold, rear

- Procedure:**
1. Remove the intake air manifold
Please refer to repair instructions 11 61 050
 2. Replace the sealing cap (1) on the vacuum connection and secure it with a retainer ring (2) (please refer to Fig. 1)
 3. Secure the fuel pressure regulating valve vacuum hose with a retainer ring (2) (please refer to Fig. 1)

Note: The retainer rings (2) should be fitted so that the lugs on the retainer rings point downwards and sit against the sealing cover

4. Renew the sealing cap (3) on the vacuum connection (E31 only) (please refer to Fig. 1)
5. Install the intake air manifold using new gaskets
