Various electrical faults in front section of vehicle

E38

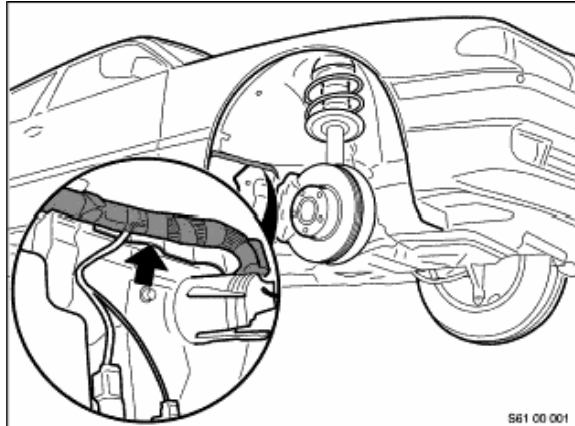
The wiring harness can be damaged by the metal panel (arrow) in the front-right wheel housing.

The previously known area (arrow) is located above the fluid reservoir of the windscreen washer system.

2. Remove the front right wheel and inner wheel housing trim.
3. Expose the wiring harness (see illustration above) from its retainers.
4. Remove the wiring harness insulation in the area described (arrow).

5. Expose and check the wires: if no damage can be detected, proceed with point 8.
6. Disconnect vehicle battery.
7. Repair any damaged wires as per Repair Instructions.
Please refer to "Repairing a plug connection on a wiring harness using a butt connector".
Repair Instructions 61 13...

8. Then wrap the wiring harness up along its length with insulating tape.
9. In addition, secure a foam support to the wiring harness with cable ties in the critical area.

10. Secure the wiring harness taught and free from vibrations.
11. Reinstall the wheel housing trim and wheel.
