Rustling noise from the valve timing gear/VANOS

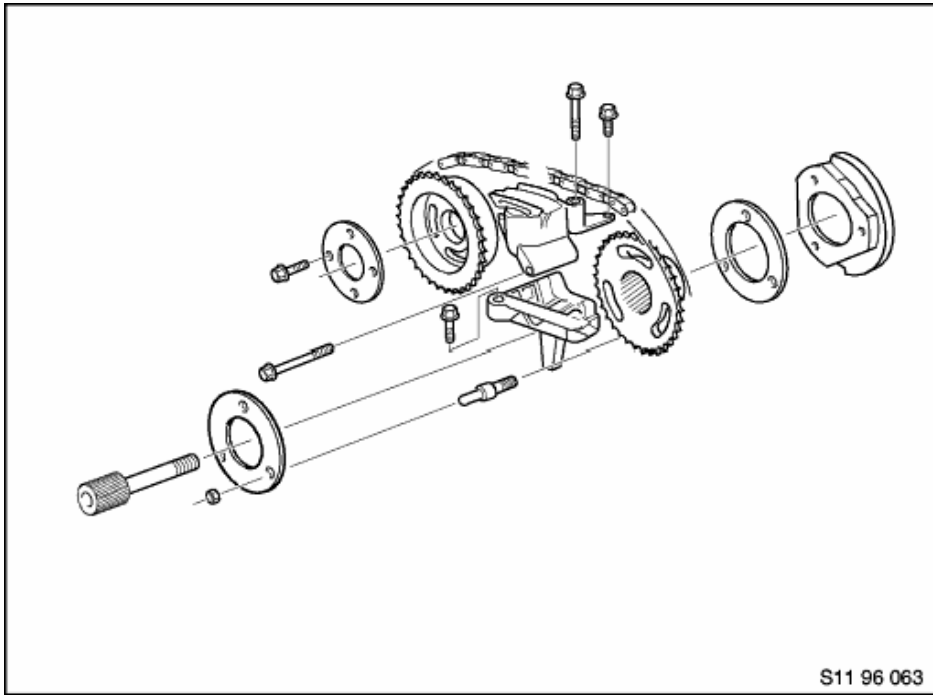
Rustling noises in the area of the timing chain, variable camshaft control (VANOS), camshaft in cold running mode up to an engine speed of 3,000 rpm.

Excessive clearance between the thrust washer and the inlet camshaft sprocket wheel.

Fig. 2:
Variable camshaft adjustment - old version without plate springs up to June 1995

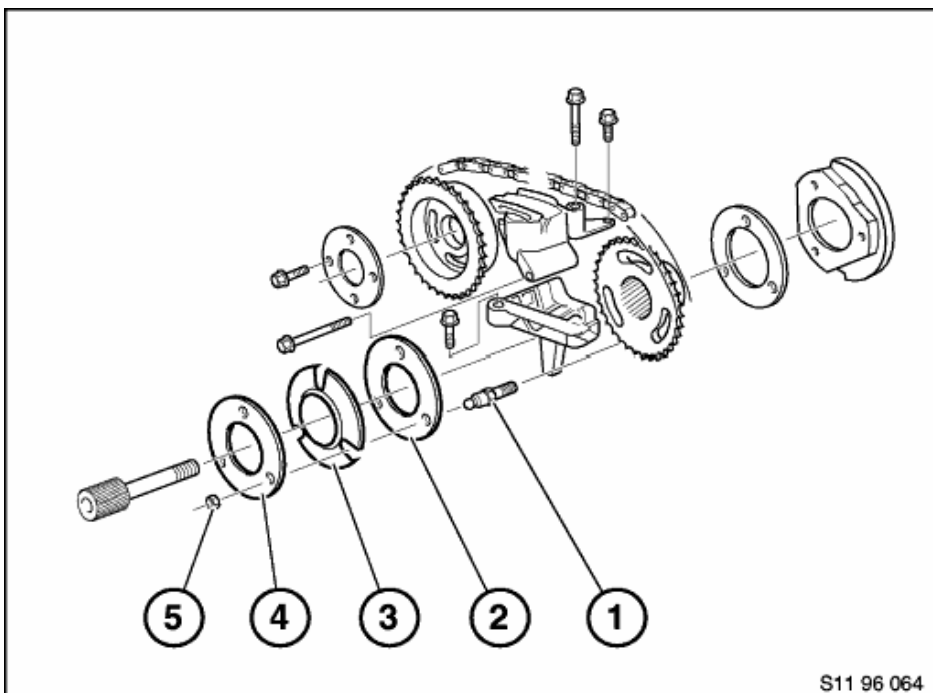
Fig. 3:

Variable camshaft adjustment - new version with plate springs since June 1995

- 1) Stud bolt
- 2) Thrust washer 2 mm
- 3) Plate spring
- 4) Thrust washer 4 mm
- 5) Nut

Convert the VANOS adjustment unit to plate springs. This solution was introduced to series production in June 1995.

- Remove cylinder head cover.
- Remove VANOS adjustment unit.
See M50 repair instructions - 11 36 010
Please refer to M52 repair instructions - 11 36 010
- Remove inlet camshaft sprocket wheel.
- Install 3 new stud bolts (Fig. 3, item 1).
Application torque: 5 Nm
Joint torque: 22 Nm
- Reinstall sprocket wheel.
- Fit on thrust washer, 2 mm thick (Fig. 3, item 2).
- Fit on plate springs (Fig. 3, item 3). Note installation direction of plate springs: fit with the large support diameter facing the camshaft.
- Fit on thrust washer, 4 mm thick (Fig. 3, item 4).
- Screw on hexagon nuts (Fig. 3, item 5), using Loctite 273 screw locking varnish.
Tightening torque: 10 Nm
- Install VANOS adjustment unit
