Intake air manifold leaking

E31, E38, E39 with M62

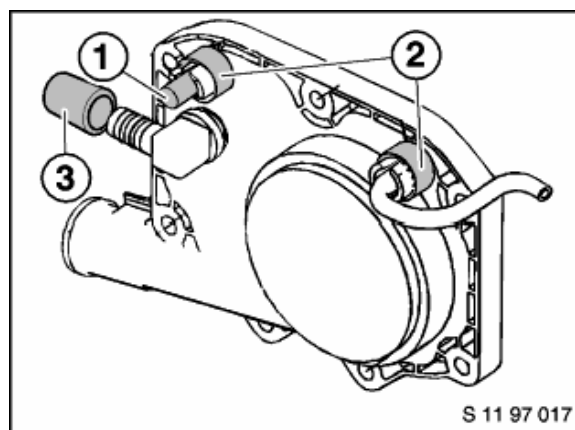
- at the gaskets between the manifold and the cylinder heads due to the different thermal expansion characteristics of the different components
- at the vacuum connections on the rear end cover of the manifold due to porous sealing caps or connections

Fig. 1: Sealing cover on manifold, rear

1. Remove the intake air manifold
Please refer to repair instructions 11 61 050
2. Replace the sealing cap (1) on the vacuum connection and secure it with a retainer ring (2) (please refer to Fig. 1)
3. Secure the fuel pressure regulating valve vacuum hose with a retainer ring (2) (please refer to Fig. 1)

The retainer rings (2) should be fitted so that the lugs on the retainer rings point downwards and sit against the sealing cover

4. Renew the sealing cap (3) on the vacuum connection (E31 only) (please refer to Fig. 1)
5. Install the intake air manifold using new gaskets
