"Stick-slip" effect in accelerator pedal module

E38, E39, E46, E52, E53, E65, E66, R50, R53 / M47TU, M54, M57, M62TU, N40, N42, N62, S54, S62, W10, W11

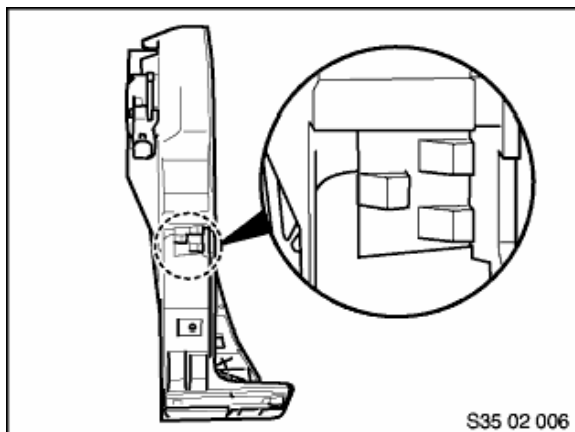
If it is not possible to pull the accelerator pedal module off after it has been levered out, the retainer has caught on the second hook.

Remove the accelerator pedal module. Please refer to Repair Instructions 35 40 001.

If this happens, lever it out a second time.
