## Various electrical faults in front section of vehicle

E38

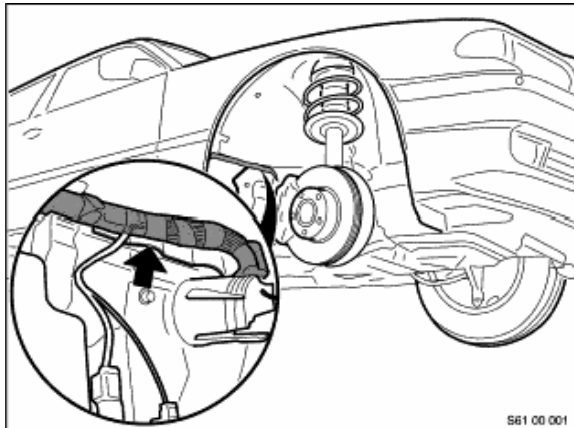
**Cause:** The wiring harness can be damaged by the metal panel (arrow) in the front-right wheel housing.

The previously known area (arrow) is located above the fluid reservoir of the windscreen washer system.

2. Remove the front right wheel and inner wheel housing trim.
3. Expose the wiring harness (see illustration above) from its retainers.
4. Remove the wiring harness insulation in the area described (arrow).

5. Expose and check the wires: if no damage can be detected, proceed with point 8.
6. Disconnect vehicle battery.
7. Repair any damaged wires as per Repair Instructions.  
Please refer to "Repairing a plug connection on a wiring harness using a butt connector".  
Repair Instructions 61 13...

8. Then wrap the wiring harness up along its length with insulating tape.
9. In addition, secure a foam support to the wiring harness with cable ties in the critical area.

10. Secure the wiring harness taught and free from vibrations.
11. Reinstall the wheel housing trim and wheel.
